# Flint Lake Aquatic Vegetation Management Plan 2007-2011

**February 19, 2007**

Prepared for: Valparaiso Lakes Area Conservancy District 1805 Burlington Beach Road Valparaiso, IN 48383

> Prepared by: Aquatic Control, Inc. PO Box 100 Seymour, Indiana 47274

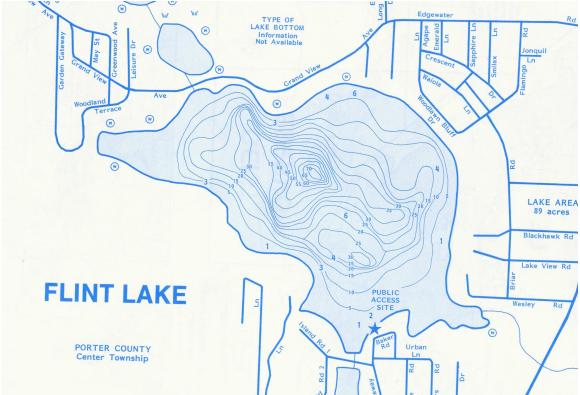
Figure 1. Flint Lake Bathymetric Map (Bright Spot Maps, 1999)

Flint Lake has extensive shallow areas with 45% of the lake area less than ten feet deep. The two coves in the northwest and southeast corners of the lake are the shallowest regions of the lake. Despite the extensive shallow areas, Flint Lake possesses a greater percentage of deeper water compared to other lakes in the chain. The relative abundance of deeper waters in Flint Lake increases recreational opportunities on the lake (JFNew, 2003).

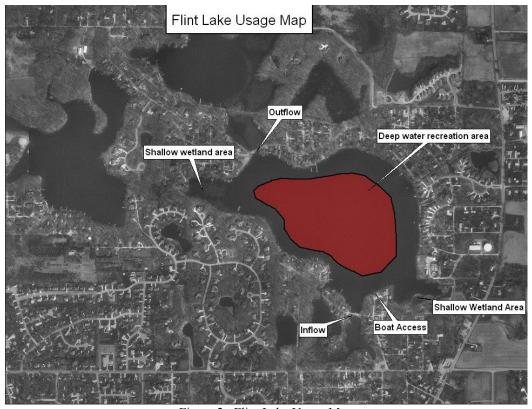
Figure 2. Flint Lake Usage Map

Flint Lake has been a resort site for Porter County residents for over a hundred years (VLACD website). Today, Flint Lake is used for a variety of activities. An access site is located along the southern shore. Virtually the entire shoreline of Flint Lake is developed residentially. The only undeveloped areas include two small bays in the southeast and northwest corners or the lake (Figure 2). Fishing, boating, and swimming are popular activities on Flint Lake. At a recent public meeting, lake users indicated that 50% used

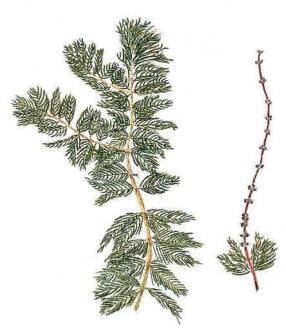
Figure 3. Illustration of Eurasian watermilfoil (Illustration provided by Applied Biochemist).

Eurasian watermilfoil is an exotic invasive species of submersed vegetation that was likely introduced into our region prior to the 1940's (Figure 3). This species commonly reaches nuisance levels in Indiana Lakes. Once established, growth and physiological characteristics of milfoil enable it to form a surface canopy and develop into immense stands of weedy vegetation, outcompeting most submersed species and displacing the native plant community. These surface mats can severely impair many of the functional aspects of waterbodies such as maintenance of water quality for wildlife habitat and public health, navigation, and recreation. Furthermore, a milfoil-dominated community can greatly reduce the biodiversity of an aquatic system and negatively impact fish populations (Getsinger et. al., 1997).

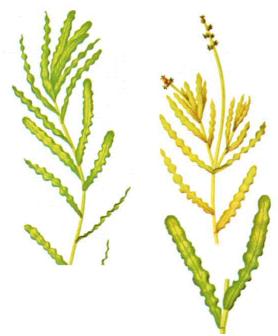
Figure 4. Illustration of curlyleaf pondweed (Illustration provided by Applied Biochemist).

Curlyleaf pondweed is an invasive exotic submersed species that was likely introduced in the early 1900's. It is present in many Indiana natural lakes and manmade impoundments. Curlyleaf pondweed's wavy serrated leaves give it a rather unique appearance (Figure 4). Richardon's pondweed (*Potamogeton richarsonii*) is probably the only species that it can be easily confused with. Curlyleaf pondweed has the tendency to create dense surface mats in the spring and early summer. These mats can interfere with recreation and limit the growth of native species. Another problem associated with this species is caused by its summer die-off that tends to lead to algae blooms. The summer die-off also tends to lessen the impact of this species on lake recreation.

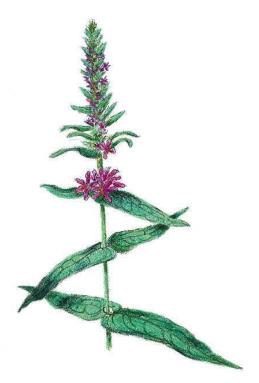
Figure 5. Illustration of Purple Loosestrife (Illustration provided by Applied Biochemist).

Purple loosestrife is an exotic invasive species of emergent vegetation that has invaded many wetlands and lake margins throughout Indiana (Figure 5). This species was introduced from Eurasia and became established in the estuaries of northeastern North America by the early 1800's. The impact of purple loosestrife on native vegetation has been disastrous, with more than 50% of the biomass of some wetland communities displaced. Impacts on wildlife have not been well studied, but indicate serious reduction in waterfowl and aquatic furbearer productivity (Thompson et. al., 1987).

As mentioned when discussing goal number one, purple loosestrife can be detrimental to native wetland species. Control of this species will not be funded by LARE due to the extent of the problem, expense associated with control efforts, and controversy surrounding control on private property. If this species is discovered on one's property, it will be important to individual homeowners to dig up and remove the entire plant. An illustration of this species was included in Figure 5 located on page 7 of this plan.

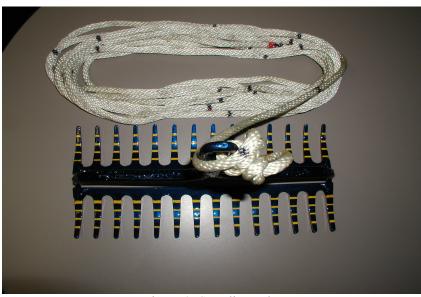
Figure 6. Sampling Rake

The number and depth of sampling sites are selected based upon lake size and classification. Once a site was reached the boat was slowed to a stop and the coordinates were recorded on a hand-held GPS unit and later downloaded into a mapping program. A depth measurement was taken by dropping a two-headed standard sampling rake that was attached to a rope marked off in 1-foot increments (Figure 6). An additional ten feet of rope was released and the boat was reversed at minimum operating speed for a distance of ten feet. Once the rake is retrieved the overall plant abundance on the rake is scored with either a 0 (no plants retrieved), 1 (1-20% of rake teeth filled), 3 (21-99% of rake teeth filled), or 5 (100% of rake teeth filled) and then individual species are placed back on the rake and scored separately.

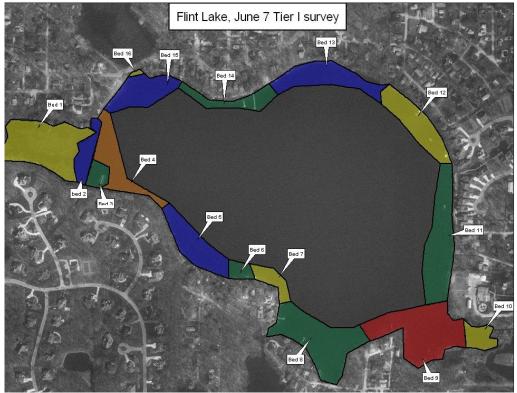
Figure 7. Tier I Plant Beds, Flint Lake, June 7, 2006

On June 7, 2006, Aquatic Control completed a Tier I survey on Flint Lake. A Secchi measurement was taken and found to be 12.0 feet. The Tier I survey revealed 16 distinct plant beds within Flint Lake totaling 30.7 acres. (Table 2 & Figure 7). Ten different species were observed.

Curlyleaf pondweed was dense in plant bed 6 and present in plant beds 5, 8, 9, 11, and 13. Eurasian watermilfoil was only observed in plant bed 8 with an abundance rating of 2.

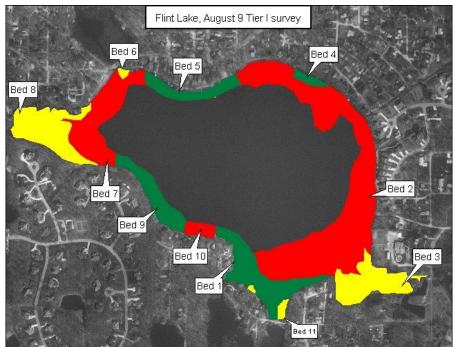
Figure 8. Tier I Plant Beds, Flint Lake, August 9, 2006

The Tier I survey was completed prior to a Tier II survey. A Secchi measurement was taken prior to the survey and found to be 8.5 feet. The Tier I survey revealed 11 distinct plant beds containing twenty-three different species totaling 45.2 acres. (Table 3 & Figure 8). Vegetation was present to a maximum depth of 17.0 feet.

There were more species observed during the summer survey, but that may have been due to the fact that a different biologist completed the survey (the detail put into a Tier I survey is still somewhat left to the interpretation of the individual). Eurasian watermilfoil was much more abundant during the summer survey than the spring survey. Eurasian watermilfoil had an abundance rating of 3 or higher in beds 2, 7, and 10. These beds encompassed an area of 25.6 acres. Eurasian watermilfoil was present, but at a lower density, in beds 1, 4, 5, 6, and 9. It appeared that the exotic Eurasian watermilfoil had replaced the native northern milfoil. Common coontail, Richardson's pondweed, and eel grass (*Valisneria americana*) were all common submersed species during the summer survey.

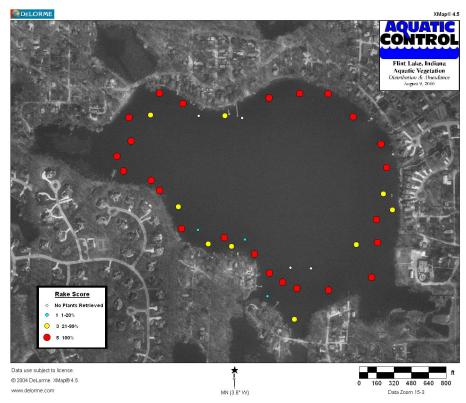
Figure 9. Flint Lake, aquatic vegetation distribution and abundance, August 9, 2006.

Common coontail was the most frequently occurring and most dominant species. Coontail was abundant at all of the depth ranges. Location and density of coontail is illustrated in Figure 10 (in species location and density figures, plant location is illustrated by a color coded dot, the color and size of the dot represents the density of the species and sample sites without that species are illustrated by smaller white diamond). Eurasian watermilfoil was the only exotic species collected. Eurasian watermilfoil was present at the second highest percentage of sample sites (47.5%) and ranked second in dominance (Figure 11). Northern watermilfoil, eel grass, and variable pondweed (*Potamogeton gramineus*) were also abundant. Eel grass was the most frequently occurring species in waters less than 5.0-feet.

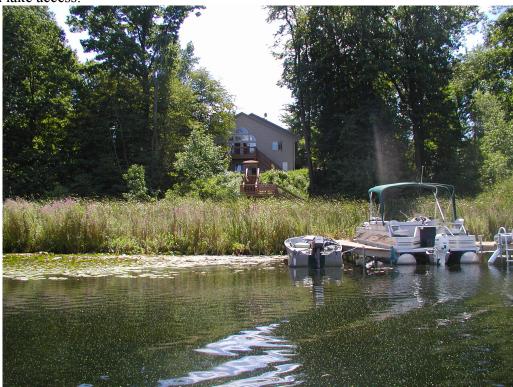
vegetation to grow. A dense shallow water plant community should help reduce erosion, prevent geese from entering and exiting the lake, provide cover for fish and wildlife, and help filter nutrients that may enter the lake from developed sites. If erosion is still a problem, glacial stone is the recommended as a replacement for rip-rap or concrete. Figure 12 is an example of a developed shoreline on Crooked Lake in Steuben County. This home site has allowed native vegetation to flourish along their shoreline yet still has

Figure 12. Crooked Lake, emergent plant community along developed shoreline, June 2006.

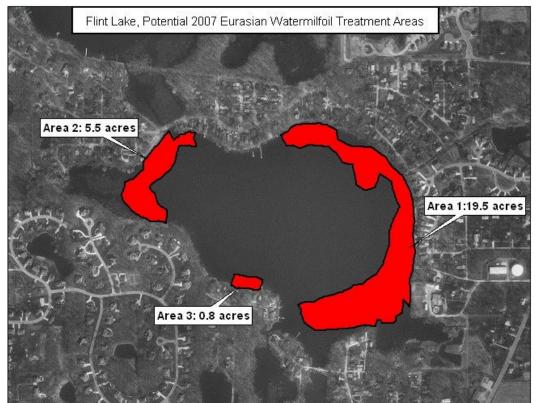
Figure 13. Flint Lake, potential Eurasian watermilfoil treatment areas.

It is the author's opinion that the best action plan for controlling Eurasian watermilfoil in Flint Lake involves the use of Renovate herbicide (active ingredient triclopyr). This action will be very selective towards Eurasian watermilfoil and has the potential to provide long-term control. Another advantage to the use of triclopyr for the control of Eurasian watermilfoil is that it will not harm some of the beneficial native plants such as coontail. In order to effectively complete this treatment, areas containing Eurasian watermilfoil will have to be mapped out prior to treatment. All areas containing Eurasian watermilfoil should be treated in late spring, following creation of a treatment map. These areas should be treated with 1.25-1.5 ppm of triclopyr. Treatments will likely need to be repeated the following season due to the difficulty in finding and controlling all milfoil plants and due the presence of this species in other connected lakes. However, the abundance of this species should be significantly reduced in following years. The goal of this control is to keep Eurasian watermilfoil frequency of occurrence below 5% so that the Conservancy can easily fund future controls. Based on last season's sampling, approximately 26 acres will require treatment (Figure 13). Non-turf irrigation will be the primary water-use restriction following treatment. Typically, after 7-14 days, triclopyr levels are low enough to irrigate. However, in order to be certain that these levels are low enough, an assay should be completed before irrigation is allowed. There are no swimming or fishing restrictions associated with use of this herbicide.

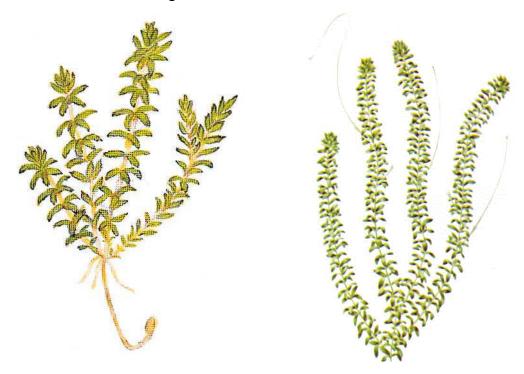
Hydrilla, an extremely aggressive submersed aquatic plant species, has been recently discovered in Lake Manitou, which is located in north central, Indiana. Currently, it is believed that this plant is isolated in the Lake Manitou area, but much like Eurasian watermilfoil, this species has the ability to reproduce by fragmentation. This allows it to be spread easily from lake to lake. It is very important that lake users understand the importance of thoroughly cleaning off their boats when entering and exiting Flint Lake. Posting signs at the ramp will help reinforce this point. Warnings about this plant should also be sent to members of the Association. The best way to distinguish hydrilla from native elodea is that hydrilla typically has five leaves along each whorl along with visible serrated edges along the leaf margin (Figure 14). More information about controlling the spread of hydrilla can be found at <a href="www.protectyourwaters.net">www.protectyourwaters.net</a>. An illustration of hydrilla and native elodea follows in Figure 14.

Figure 14. Illustration of hydrilla on the left compared to native elodea on the right. Hydrilla typically contains five toothed leaves per whorl while native elodea typically has three leaves per whorl and the teeth are not visible on the leaves (Illustrations provided by Applied Biochemist).
